Powell River Salmon Society July 2015

Lang Creek

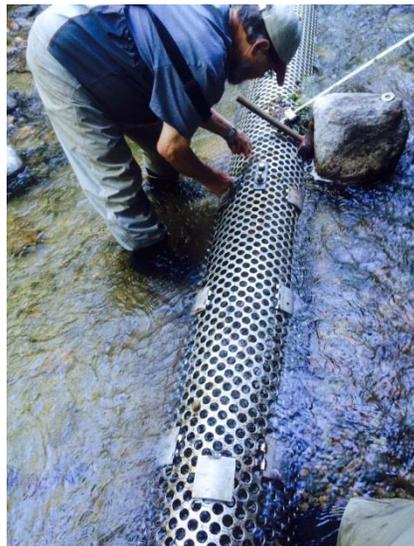
We have made some intake modifications at Lang Creek. The modification was the installation of a service window in the intake itself. A disk grinder was used to cut the window which was fitted with tabs for reinstallation.

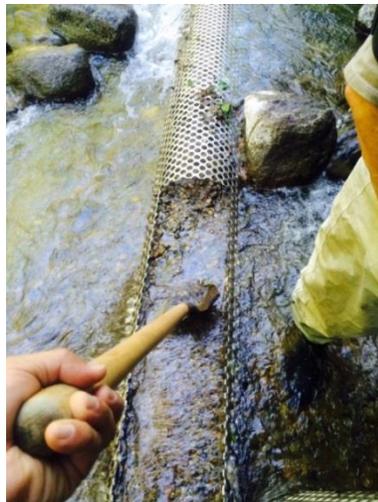
It is not uncommon for gravel to make its way into the intake. Eventually it works its way down the intake and into our pipeline and on into our headwater tank at the Lang Brood Facility. It then passes into the brood tanks where we have to clean it out. However, given the floods last fall and winter we experienced a far greater volume of material in our intake reducing water capacity. For this reason we made an entry point to which we can shovel out the sand and gravel material from inside the intake itself.

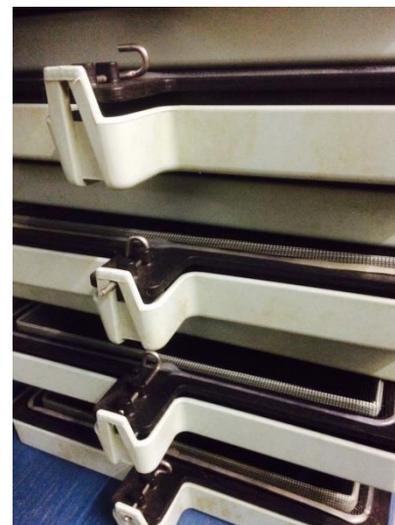
Our new heath trays arrived and have been placed into the trays in the incubation room.
